BABSON RESERVOIR DAM

MA 00187

PHASE I INSPECTION REPORT
NATIONAL DAM INSPECTION PROGRAM

NOVEMBER 1978

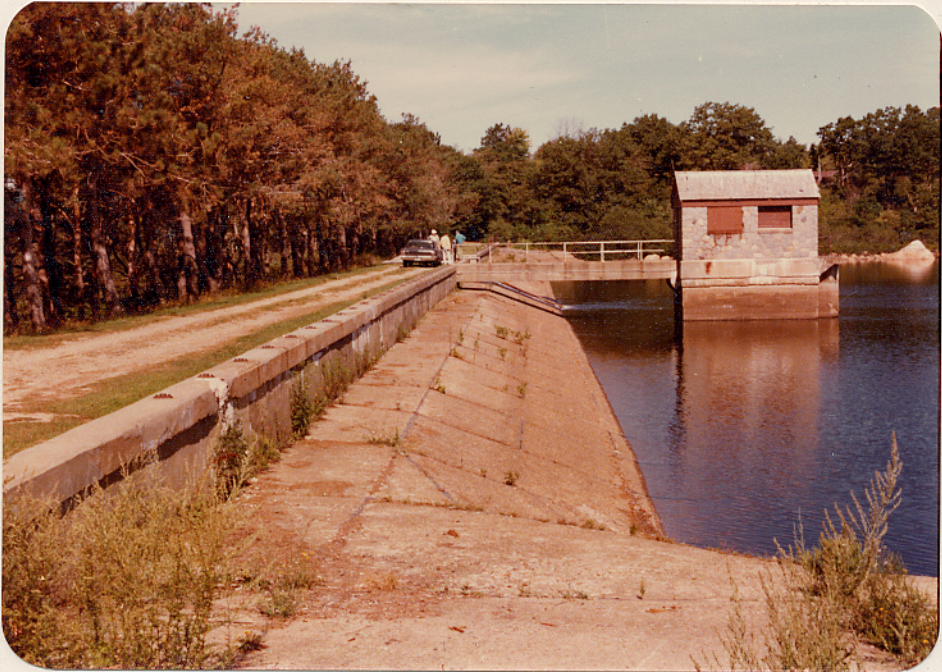
1. Overview of crest and upstream slope from left abutement.
